CASMALIA RESOURCES HAZARDOUS WASTE MANAGEMENT FACILITY

WHAT IS THE CASMALIA RESOURCES HAZARDOUS WASTE MANAGEMENT SITE?

March 2002

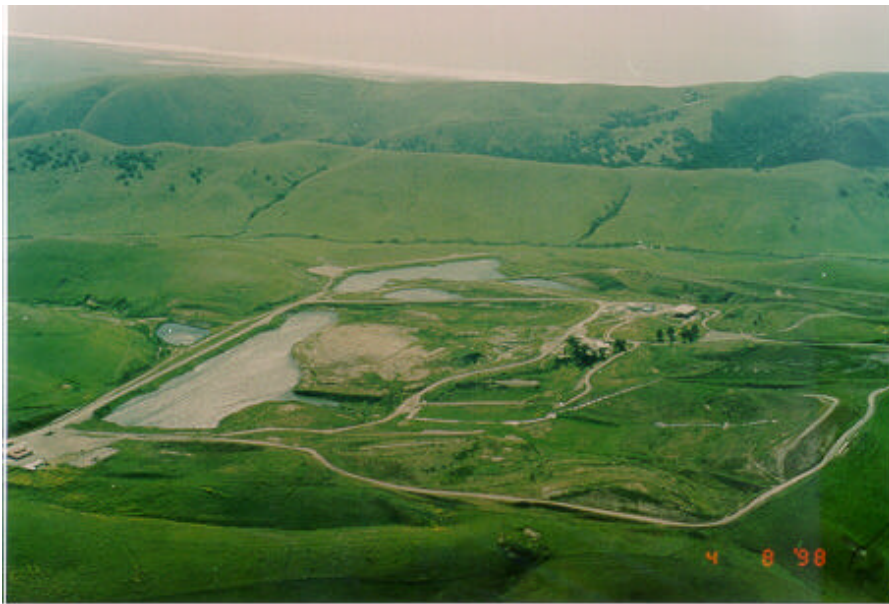
Looking southwest in April 1998

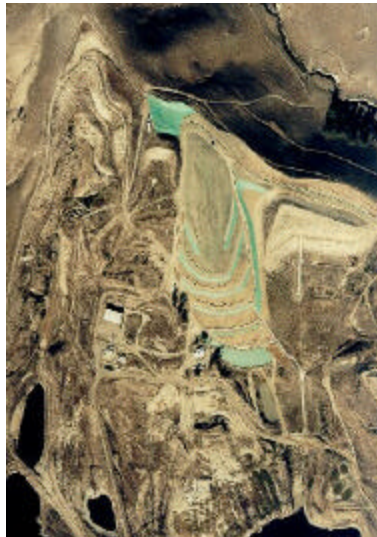
Capping of four of the six landfills began with placement of a multi-layer cap on top of the Pesticides/Solvents landfill in the summer of 1999. The multi-layer cap for this largest landfill on the facility consisted of 5 layers. The bottom most layer consists of 2 feet of compacted soil, followed by a plastic liner made of high-density polyethylene (HDPE). Both the compacted soil and HDPE layers are to prevent rain water from infiltrating into and through the landfill waste. Above the HDPE liner is a plastic screen “sandwiched” between fabric material. The “sandwiched” screen channels infiltrated rain water down-slope where the water then comes to the surface (“daylights”) into constructed surface drainage channels. Above the “sandwiched” screen is the top “vegetative” layer of at least 2 feet of compacted clean soil. The purpose of the vegetation on the top most soil layer is to prevent erosion. Also, bisecting this vegetative layer is another plastic screen, which acts to prevent animals from burrowing through the cap.

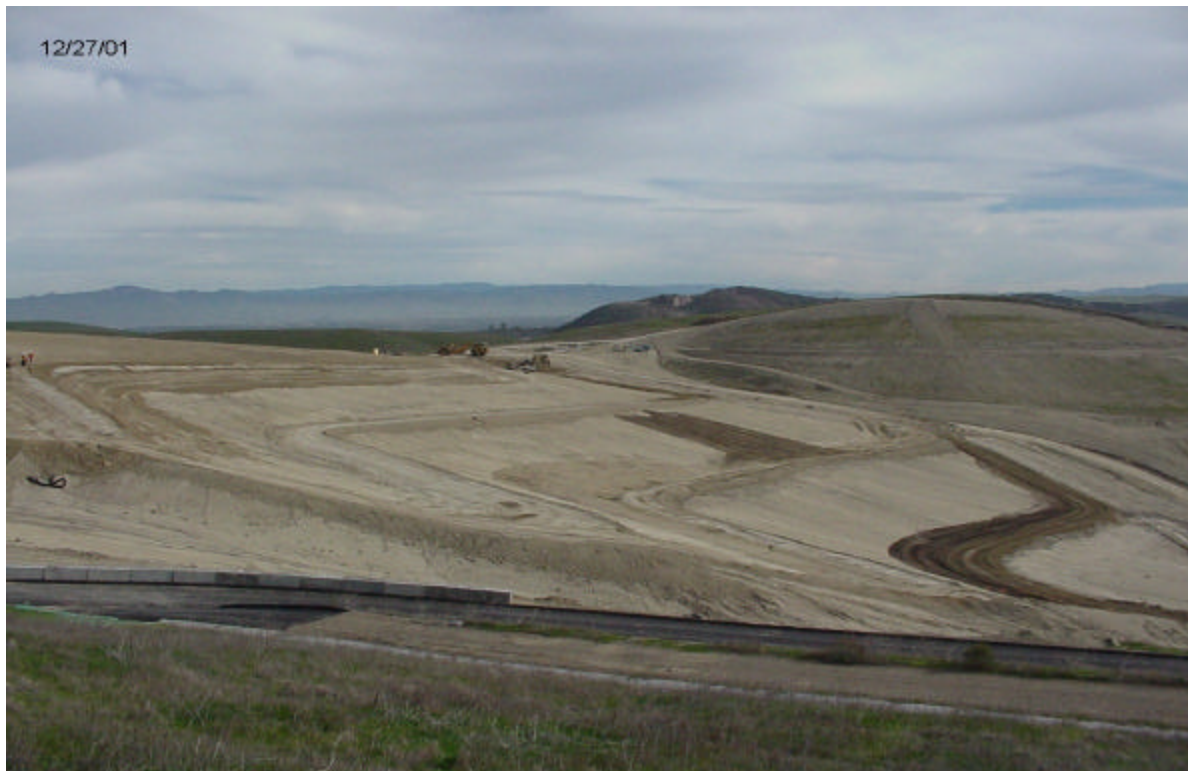
Metals Landfill with Caustic/Cyanide Landfill in Background

Work in the summer of 2001 included construction caps over three more landfills: the Metals/Sludges, the Caustic/Cyanide, and the Acids; and to correct work performed on the Pesticides/Solvents landfill. The cap designed for the three landfills was very similar to that used for the Pesticides/Solvents landfill cap. The major difference between the designs was utilizing a “geosynthetic clay liner” in place of the two feet of compacted soil. Because drums were found unexpectedly near the crest surface of the Caustic/Cyanide, only construction of the Metals/Sludges landfill cap and corrective action on the Pesticides/Solvents cap occurred.

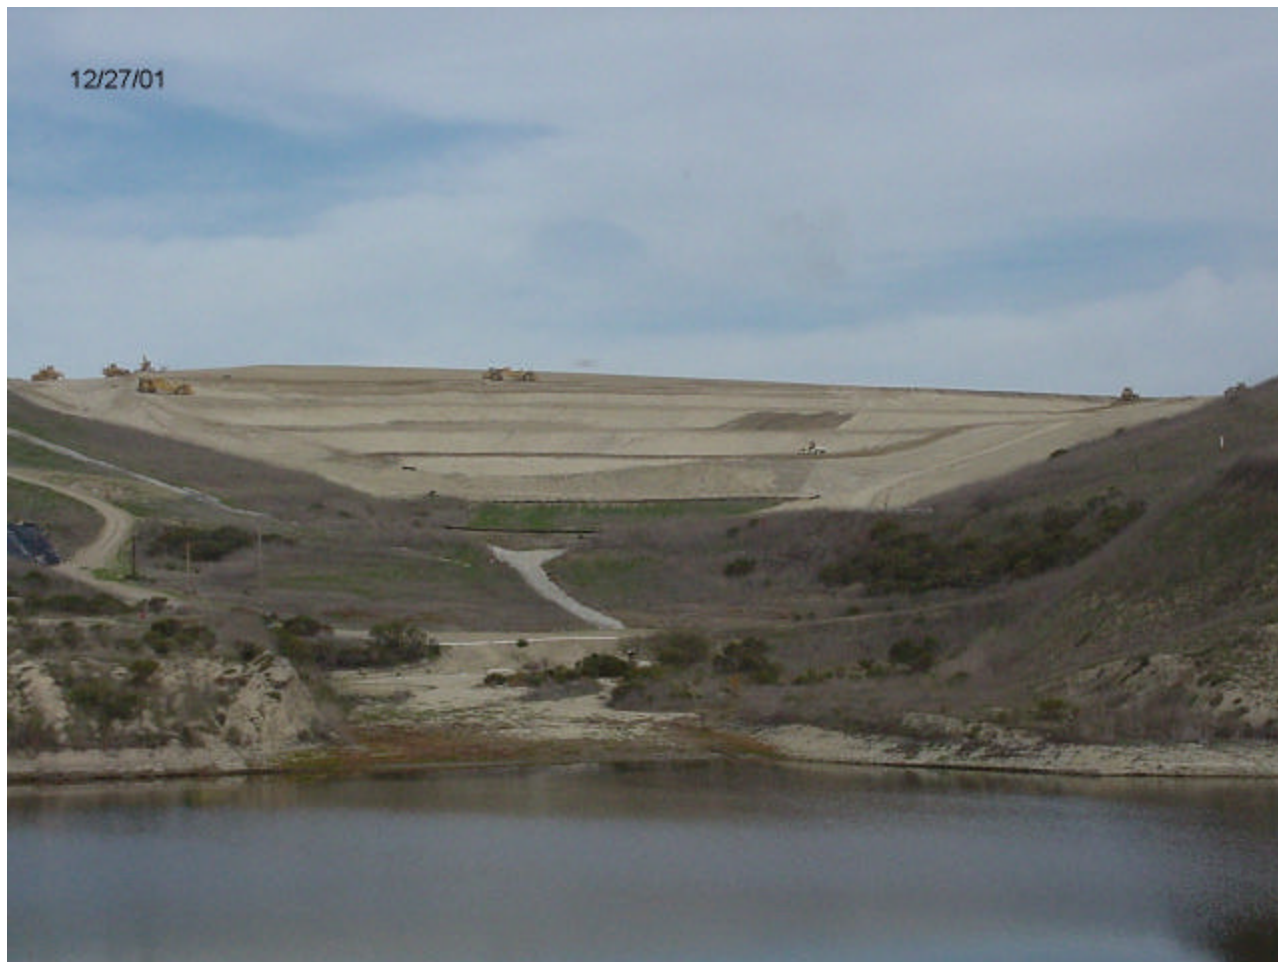
Metals Landfill with RCF Pond in Foreground

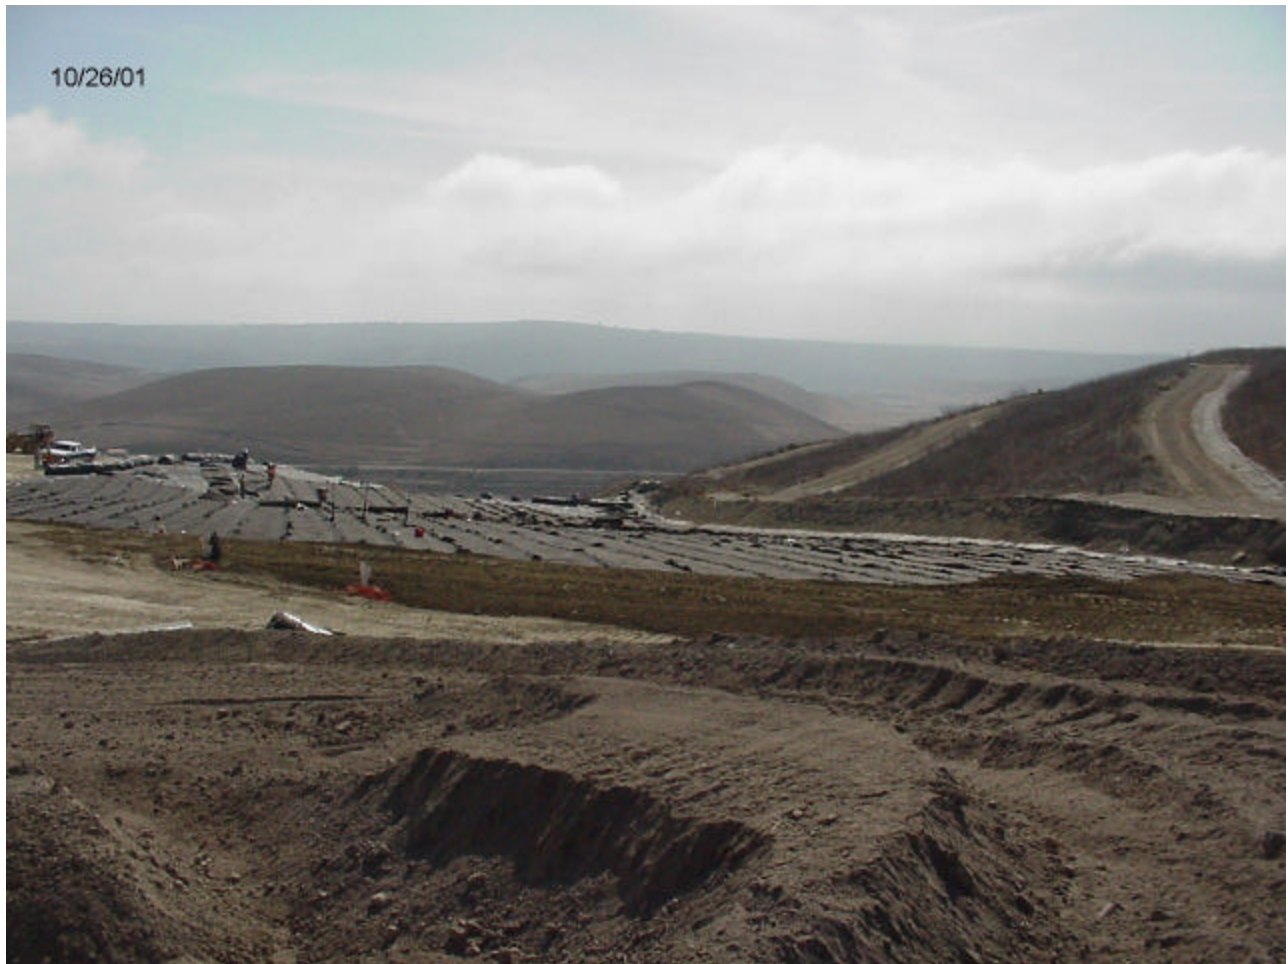
Metals Landfill - Interstitial Area

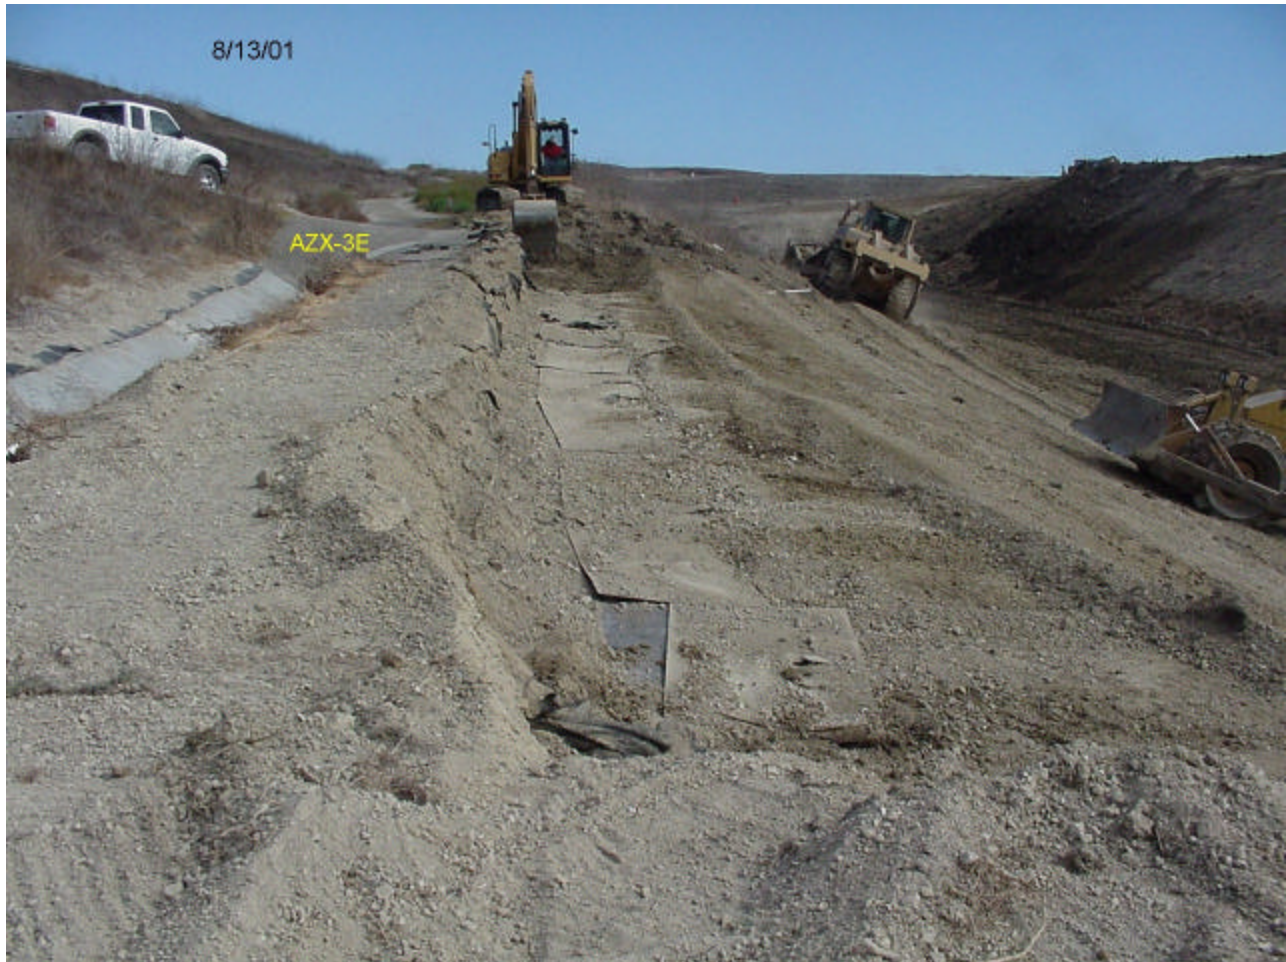
Pesticide/Solvent Tie-in Work to Metals Landfill
